No. 10-03-02-02R/04

SYSTEM: Space Shuttle RSRM 10 CRITICALITY CATEGORY: 1

SUBSYSTEM: Ignition Subsystem 10-03 PART NAME: Redesigned Barrier-Booster Assembly (1)

1.0 FAILURE CONDITION: Failure to operate (B)

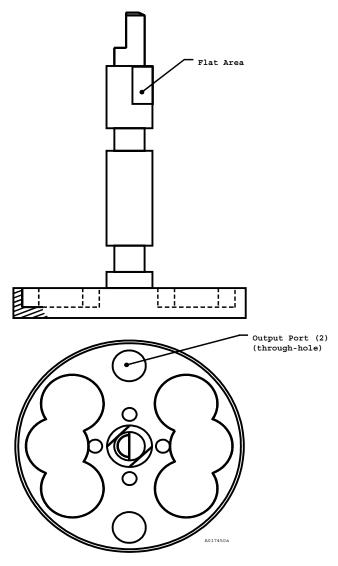
Figure 1. Output Barrier Rotor

1.0 Rotor blocks SRM Ignition Initiator (SII) output 2.0 FAILURE MODE:

Nonconforming dimensions/location of holes in barrier Α 1.1

1.2 Contamination blocking ports in Barrier-Rotor В

В The Barrier-Booster Rotor is cleaned per engineering drawings. a. В Threaded protectors are installed in the SII holes, two places. b. В A shipping cover is installed over the rotor per engineering drawings. C. Procedures and requirements for cleanliness and contamination control are В established per engineering drawings. Refurbishment of the Barrier-Booster Assembly is as follows: Refurbishment of the Barrier-Booster Assembly, of which the rotor is a A,Bcomponent, is per engineering and acceptance criteria. В Procedures and requirements for cleanliness and contamination control are b. established per engineering drawings. Reusable components of the Barrier-Booster Assembly including the rotor are Α reassembled to the assembly from which they came at refurbishment per engineering drawings.

Rotor dimensions are controlled per engineering drawings.
